Title no. 99-S34

# Behavior of Repaired Cyclically Loaded Shearwalls

by Frank J. Vecchio, Omar A. Haro de la Peña, Filippo Bucci, and Daniel Palermo

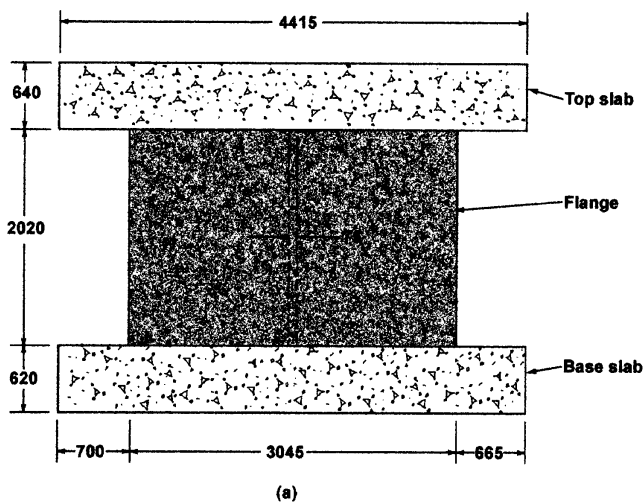
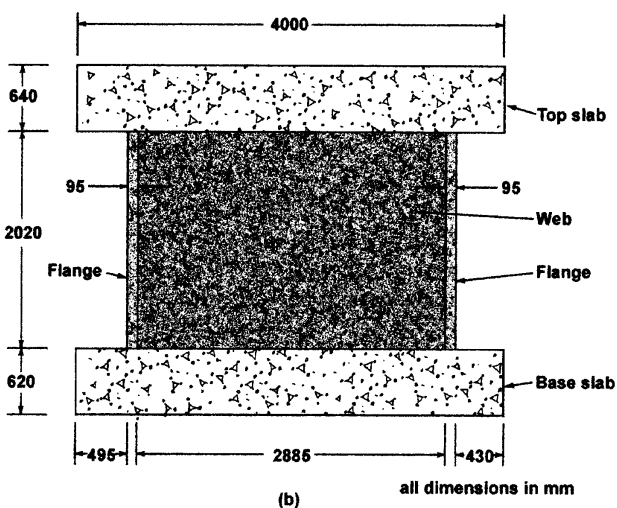
Fig. 1—Details of shearwall specimens: (a) end view; and (b) side view.

All walls were similar in terms of configuration, overall dimensions, and reinforcement details. As shown in Fig. 1,

the walls were of H-section type, built integrally with stiff top and bottom slabs. In the typical specimen, the storey height, from the top of the base slab to the soffit of the top slab, was 2020 mm. The web sections were 75 mm thick by 2885 mm wide, and the flanges were 3045 mm across. The flange thickness was 95 and 100 mm for Specimens DP1/DP1R and Specimens DP2/DP2R, respectively.

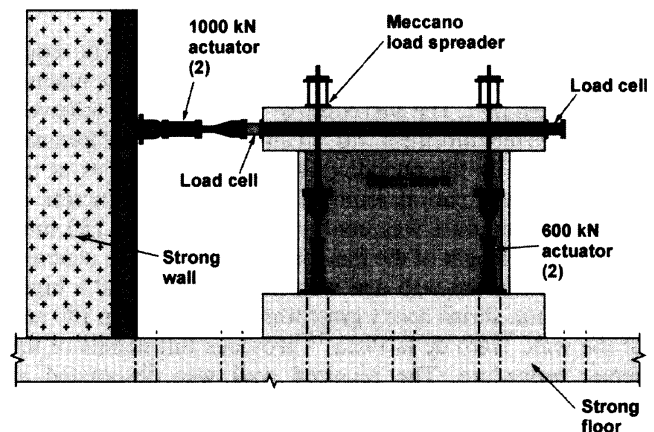
Fig. 3—Test setup.

The testing apparatus used to apply combinations of lateral and axial loads to the wall specimens is illustrated in Fig. 3. The base slab of the test specimen was post-tensioned to the laboratory strong floor. Axial loads were applied by means of four 600 kN actuators, fixed to the strong floor and reacting against two spreader beams lying across the top slab. Lateral displacements were applied to the top slab by two 1000 kN

servo-controlled actuators reacting against a strong wall. The mid-height of the top slab served as the reference point for monitoring the imposed displacements.

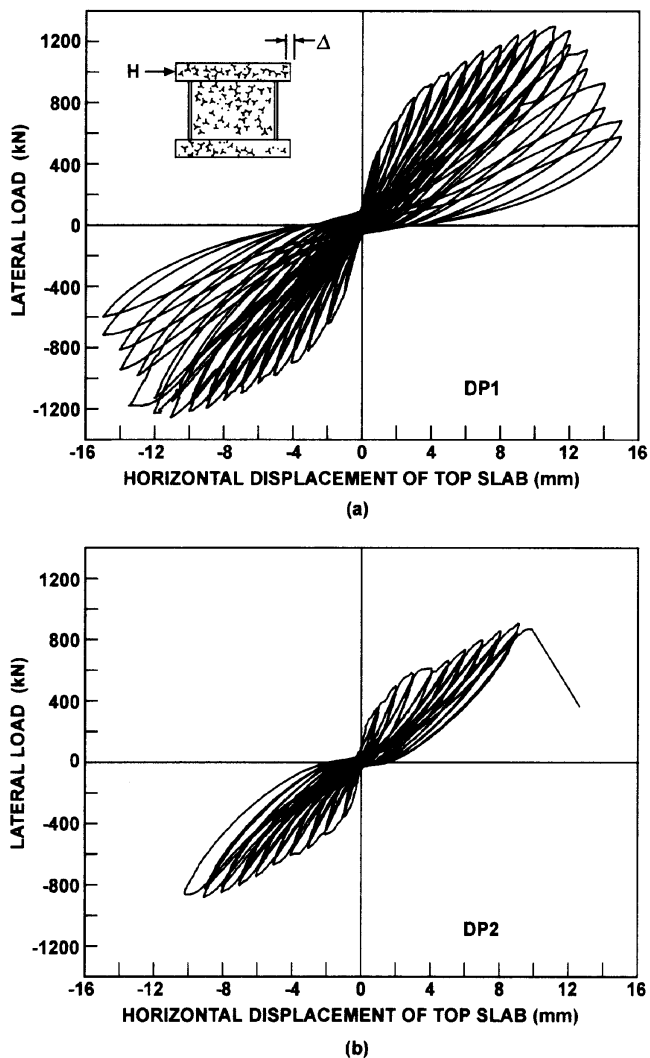
Fig. 4—Load-displacement responses of original walls: (a) Specimen DP1; and (b) Specimen DP2.

Specimen DP1 was subjected to a constant axial load of 1200 kN, and incrementally increasing reversed cyclic lateral displacements. The wall was able to sustain a maximum lateral load of 1298 kN, at a corresponding lateral displacement of 11.1 mm. Loading was continued well into the postpeak range of response, with the lateral load resistance decaying to approximately 580 kN at a displacement of 15 mm. The wall sustained severe and widespread crushing of the concrete in the web, with the final failure mechanism involving the formation of six vertical slip planes within the web. Some local yielding of the horizontal reinforcement in the web was recorded; however, no yielding of any vertical reinforcement in the web was detected. The flange walls experienced some flexural cracking, up to widths of 1.1 mm, but remained relatively undamaged. There was no evidence of any concrete distress nor was yielding of either the horizontal or vertical reinforcement detected. The load-displacement response curve for Specimen DP1 is given in Fig. 4(a). Palermo<sup>13</sup> gives a full discussion of the test results.

significant was the pronounced damage in the web-flange joint regions, with notable punching of the web through the flanges. Yielding of the reinforcement was not detected anywhere in the web or flanges by the electrical strain gages. Concrete surface strain readings, however, indicated probable local yielding of the flange vertical reinforcement. Flexural cracks in the flanges approaching 1 mm width further suggested local yielding had occurred. The load-displacement response curve for Specimen DP2 is given in Fig. 4(b).

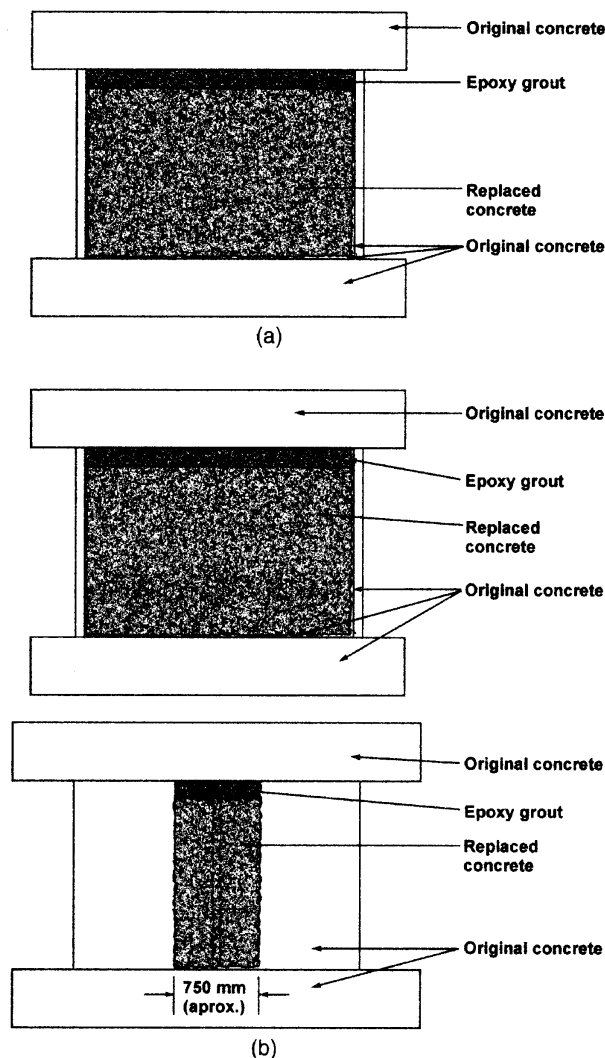
Fig. 5—Repair schemes of walls: (a) Specimen DP1R; and (b) Specimen DP2R.

Specimen DP1 was repaired by completely removing and replacing the concrete in the web component of the wall, while ensuring that the vertical and horizontal reinforcements were preserved without damage. The damaged web concrete was removed with a small pneumatic chipping hammer to within about 15 mm of the flange and top and bottom slab joint regions. The wall was then reformed and recast to a height of 180 mm from the soffit of the top slab. The top zone of the web was later completed using a high-strength, nonshrink epoxy grout in order to achieve proper bond and continuity. A schematic presentation of the repair zone is given in Fig. 5(a). Bucci<sup>14</sup> provides full details of the repair procedure. The repaired wall was designated as Specimen DP1R.

Palermo<sup>13</sup> gives a full discussion of the test results. The repair of Specimen DP2 was performed in much the same manner as Specimen DP1. The web concrete was completely removed, but the web reinforcement was left intact. The major difference, necessitated by the punching failure of the flanges at the web joint, was partial removal of the flange concrete as well. This removal was confined to a width of 750 mm, over the full height of the flanges (Fig. 5(b)). Fresh concrete was placed in the web and web-flange joints, and a high-strength, non-shrink epoxy grout was used for the top 180 mm of the wall. Haro de la Peña<sup>15</sup> provides full details of the repair procedure. The repaired wall was designated as OHSW1. For the purposes of this paper, it will be referred to as Specimen DP2R.

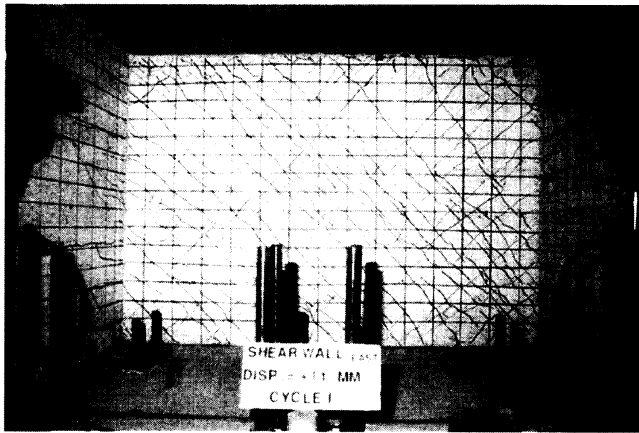
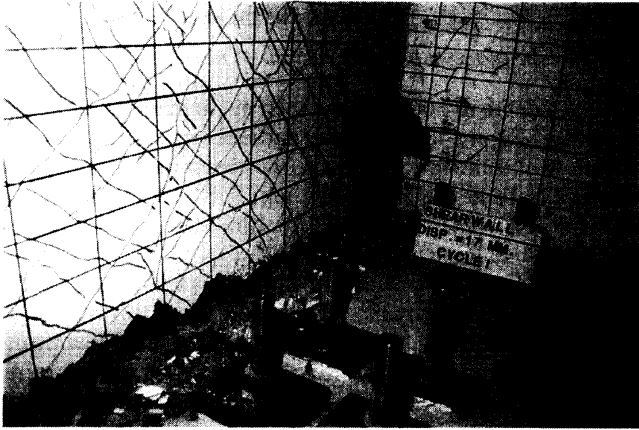
Fig. 6—Specimen DP1R: (a) at ultimate load; and (b) at failure.

In the testing of Specimen DP1R, web shear cracks became apparent at displacements as low as 1.0 mm, much sooner than evident in the original wall (Specimen DP1). Owing to the precracked nature of the flange walls, lateral load stiffness at low displacement levels was somewhat reduced. Post-cracking stiffness at intermediate load levels, however, was comparable to that of the original wall. (Note that the strength of the web concrete in the repaired wall, however, was 44.0 MPa, as opposed to 21.7 MPa in the original wall.) At a displacement amplitude of 7.0 mm, the web was extensively cracked throughout, with maximum crack widths of 0.5 mm recorded. Crack patterns and crack widths, measured using a surface gage with a precision of 0.05 mm, remained essentially stable thereafter. During the first excursion to 11 mm (0.55% drift), the maximum load capacity of 1192 kN was achieved. Figure 6(a) shows the condition of the wall at this load stage. Load resistance gradually diminished

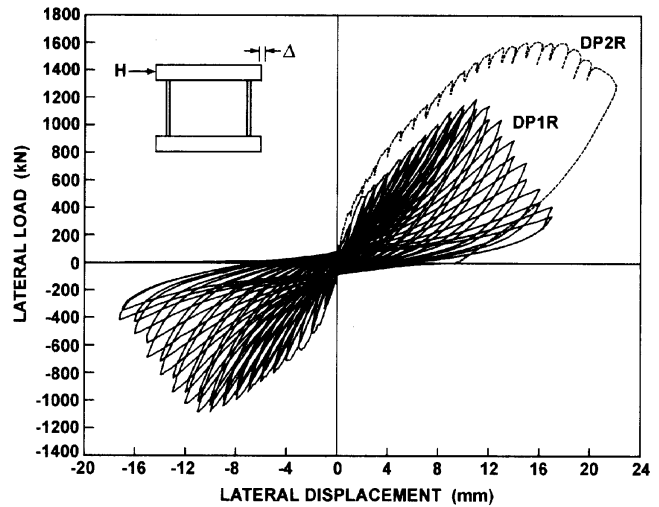
Fig. 7—Load-displacement responses of repaired walls.

thereafter. At displacement amplitude of 17 mm, the load resistance decayed to approximately 350 kN. The load-deformation response, reproduced in Fig. 7, was characterized by highly pinched hysteresis curves indicative of shear-dominated behavior. Crushing and localized spalling of the concrete was noted at displacement levels of 11 mm and above. At 12 mm displacement, the first signs of a potential punching of the web through the base of the flanges became evident. Finally, at 17 mm displacement (0.85% drift), the wall sustained a sliding shear failure along the base (just above the repair interface), coupled with punching of the web through the flanges (Fig. 6(b)). Minor localized yielding of the vertical reinforcement, in both the web and flanges, was observed in the postpeak response. Bucci<sup>14</sup> provides a full description of the test results.

for Specimen DP2R). Comparing the calculated response with the experimentally observed response (Fig. 7(a)), the behavior is reasonably well simulated. The final failure mode was also correctly predicted, involving the formation of a sliding shear plane at the base. The slightly overestimated strength and stiffness can be attributed to two factors: the two-dimensional representation of the wall overestimated the contribution of the flanges, and the analysis program used preliminary cyclic loading/unloading and damage models that are in need of further development. Work is progressing in this regard.

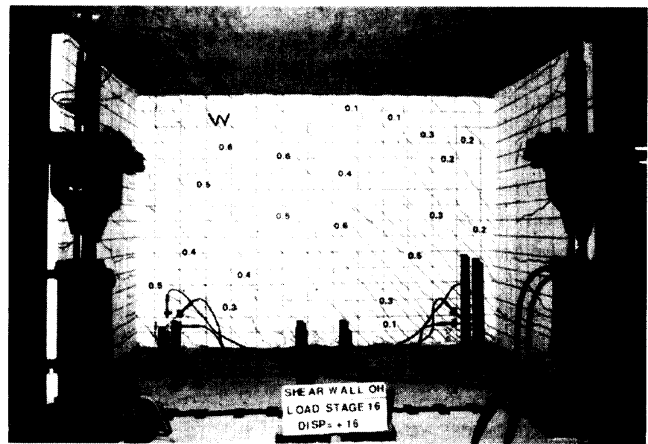
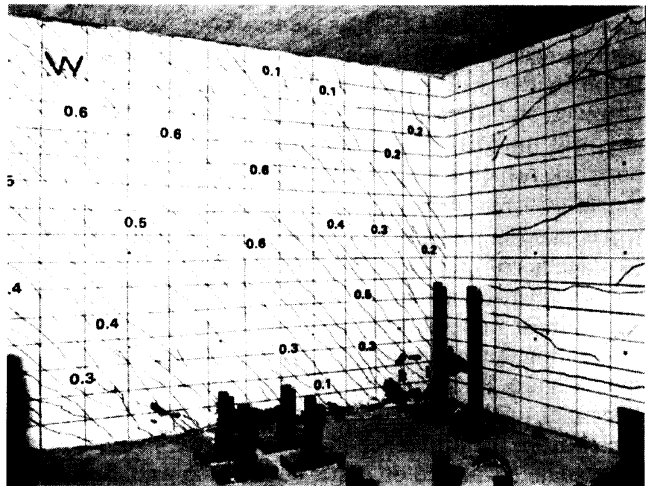
Fig. 8—Specimen DP2R: (a) at ultimate load; and (b) at failure.

in capacity occurred at 21 mm displacement. At maximum load, widespread crushing and some spalling of the concrete was observed, particularly in the compression toe region of the web. The final failure mechanism involved compression strut crushing, sliding shear along a horizontal plane above the repair interface, and punching of the web through the compression flange (Fig. 8(b)). There had been evidence of

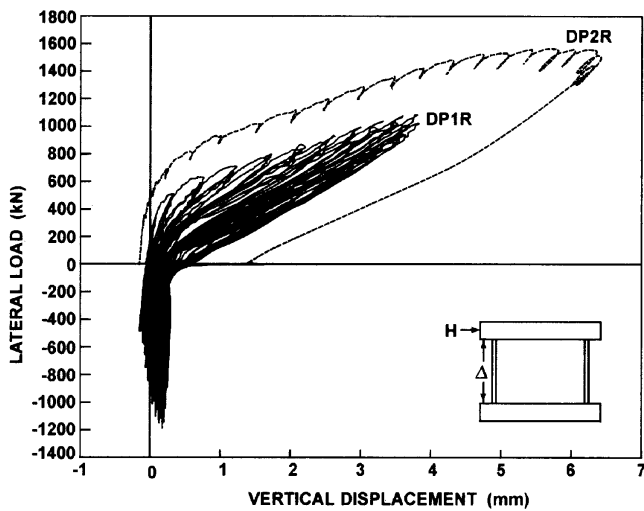
Fig. 9—Flange elongation.

The test data that are especially useful in understanding behavior and corroborating analytical models are those of a second-order nature, describing subtleties in response. Among them is the elongation of the flange walls, particularly in walls subjected to reversed cyclic loading where ratcheting (due to reinforcement yielding) may be prevalent. Figure 9 shows the progressive elongation of one of the flange walls in Specimen DP1R. Elongation of the tension flange in Specimen DP2R is also shown. Note that in the postpeak response of Specimen DP1R, as the resistance force diminishes with increased lateral displacements, there is some accumulation in the residual displacement. The effect is minor, however, and suggests that yielding of the reinforcement, if any, was minimal. The increasing flange elongation in the postpeak response of Specimen DP2R, however, confirms the influence of yielding.

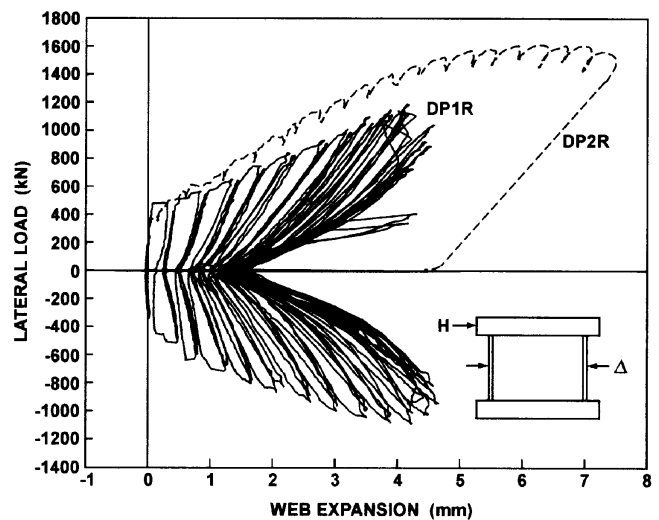
Fig. 10—In-place expansion of web at midheight.

Another important second-order mechanism is that of the in-plane horizontal expansion of the web wall at midheight. As previously discussed by Vecchio,<sup>16</sup> capturing this behavior in nonlinear finite element analyses is critical to accurately calculating the load capacity and failure mode of the structure. Figure 10 shows the web expansions measured in Specimens DP1R and DP2R. (The expansion was determined from the difference in readings from two horizontal extensometers placed on either edge of the web. See sketch in Fig. 10.) Note that even in the postpeak load stages, the wall continued to expand.

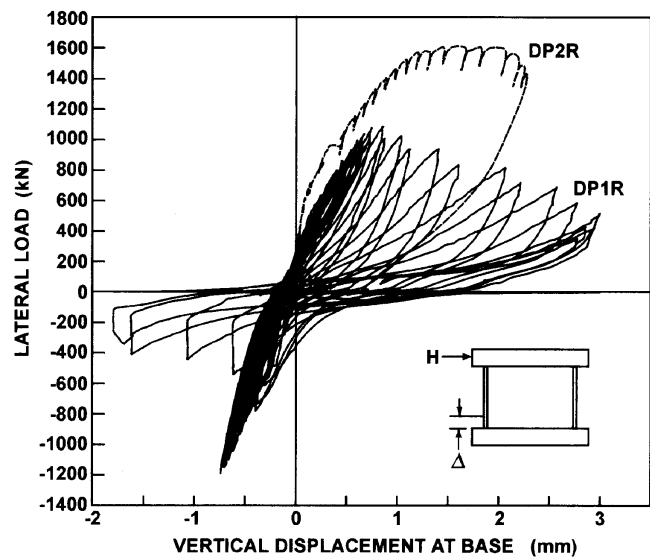
Fig. 11—Vertical displacement at base of flange.

slab, to a depth of 300 mm, and then put in place with epoxy-grouting.) Figure 11 shows the vertical displacement of the flange wall relative to the base, measured at a short height above the base (180 and 200 mm for Specimens DP1R and DP2R, respectively). With both Specimens DP1R and DP2R, comparing Fig. 11 with Fig. 9, one sees that a relatively large proportion of the total flange elongation occurred at the base region. The majority of this displacement appeared as a crack at the base of the wall. Coupling this with the observation that the reinforcement strains were post-yield but not excessive, one may conclude that some amount of bond slip in the anchorage zone of the vertical bars had taken place.

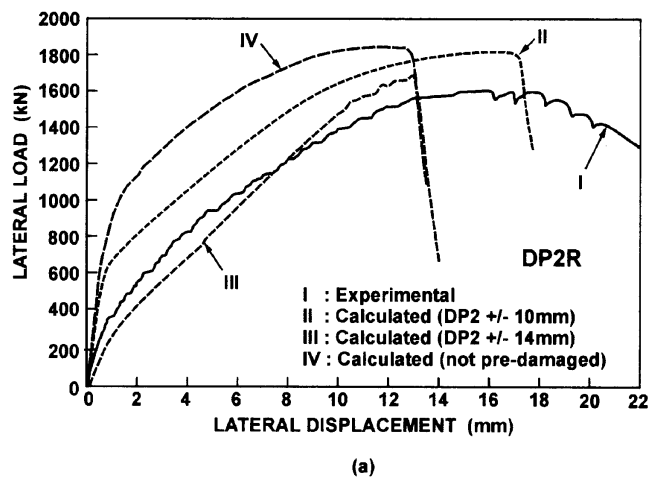
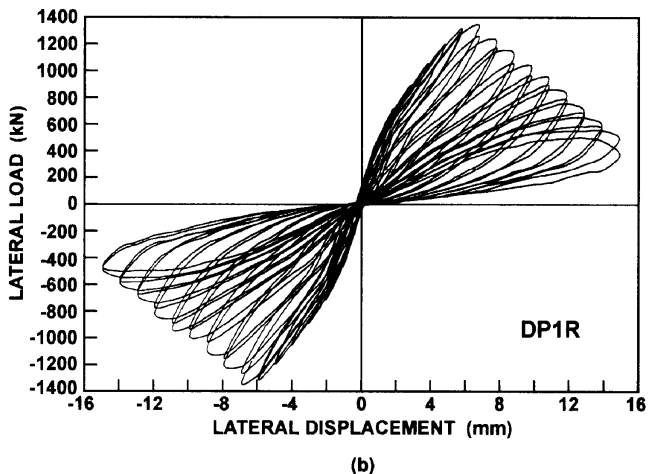
Fig. 12—Calculated load-displacement responses of repaired walls: (a) Specimen DP2R; and (b) Specimen DP1R.

damaged web elements disengaged, new (undamaged) web elements engaged, and the structure reloaded. The experimentally observed response (Curve I) is compared with the resulting calculated load-deflection response (Curve II) in Fig. 12(a). The calculated response is somewhat stiffer and stronger. Some of the discrepancy is attributable to the two-dimensional representation of a structure that, in fact, involves complex three-dimensional behaviors (that is, web-flange punching, shear lag in flanges) but some is also due to the original phase of the analysis underestimating the extent of damage in the structure. The analysis was repeated, pushing the wall to  $\pm 14$  mm displacement amplitude and hence taking it well into a postpeak (highly damaged) condition. The repair was then simulated and the wall reloaded. The calculated response is shown as Curve III in Fig. 12(a). It is seen that strength and stiffness are more accurately calculated, but the ductility is now underestimated. Hence, overestimating the damage in the original wall resulted in an overly weakened predicted response for the repaired wall, primarily from excessive damage in the flanges. The predicted response, where Specimen DP2R is analyzed as if not previously loaded, damaged, or repaired (that is, new), is shown as Curve IV in Fig. 12(a). A significant overestimation of the strength and stiffness of the wall results, coupled with a more brittle predicted failure mode.

Figure 12(b) shows the cyclic displacement response of repaired Specimen DP1R, computed using a two-stage, two-dimensional finite element analysis (as previously described
